# CLARIFICATION OF FIRE OCCURRED AT THE CHAPEL OF THE BLOOD OF CHRIST

## METROPOLITAN CATHEDRAL OF MANAGUA

## Police Investigation Results Clarification Fire in Chapel of the Blood of Christ

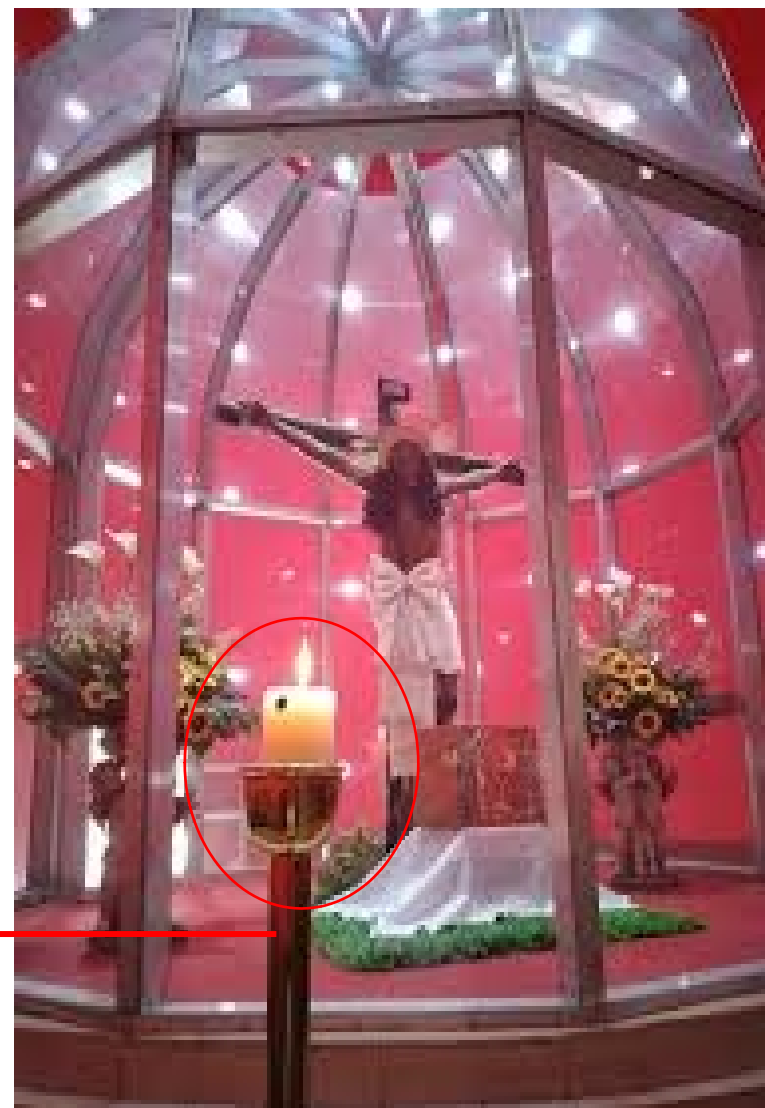
# PHOTOGRAPHIC SETTING OF THE SCENE

1. The mechanism for starting and spreading the fire originated when the alcohol vapors ascended to the roof of the chapel, carried by the air currents that enter through the access doors, and its subsequent descent through a hole in the upper part of the dome of the Blood of Christ, where they accumulated.

2. The alcohol fumes accumulated inside the dome of the Blood of Christ, when mixed with the hot air (Temperature of 36.1 ° C), produced the fire, in a process scientifically known as **desolvation**. The fire spread in the environment setting lighting the carpets, clothing of the Blood of Christ, plastic dome, all these materials susceptible to combustion, in addition to the lighted candle located at a distance of 70 centimeters from the plastic dome that protected the Blood of Christ.

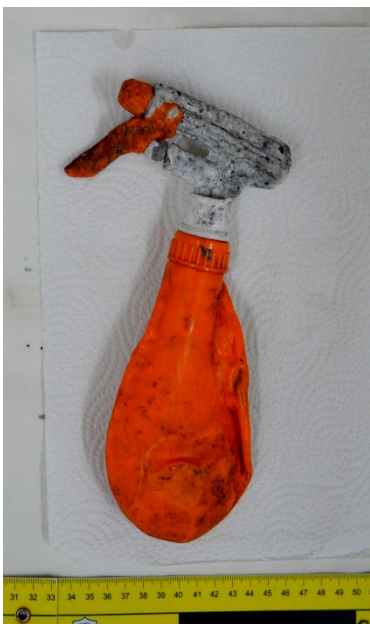
**Atomizer**

- Isopropyl alcohol with a concentration of 96% was detected in an orange-white plastic spray, which is a highly flammable volatile solvent, which generates toxic nitrogen oxide vapors and explosive mixtures in the air during combustion. (Commonly the alcohol used for hand disinfection is 70% pure).
- The presence of explosive substances such as artisan gunpowder (molotov and / or contact bomb) or industrial (TNT, C-3 and C-4) was not detected.
- No presence of Hydrocarbons (Gasoline, diesel, kerosene and Thinner) was detected.

- Isopropyl alcohol with concentration of 96%, highly flammable and volatile, contained in a plastic container (orange with white atomizer) found in the first step of the platform of the dome of the Blood of Christ at a height of 80 centimeters, located in the West side of the chapel.

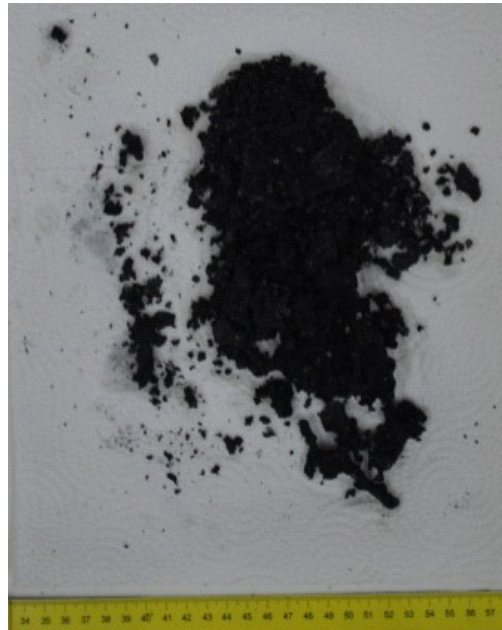
**Combustion material**

- Red carpet located on the platform of the dome of the Blood of Christ.
- Green plastic carpet located in front of the Blood of Christ.
- Artificial flowers located on the sides of the Blood of Christ.
- Holy robe of the Blood of Christ.
- Plastic material (polymethylmethacrylate) that makes up the Dome of the Blood of Christ.
- Candle resin. (incinerated transforming into carbon monoxide, carbon dioxide and water vapors)
- Glue that holds the base of the plastic structure that makes up the dome of the Blood of Christ.
